Manhole Inspection Summary

Manhole # S13CC2021MH

Location Address: **5713 CHILHAM RD**

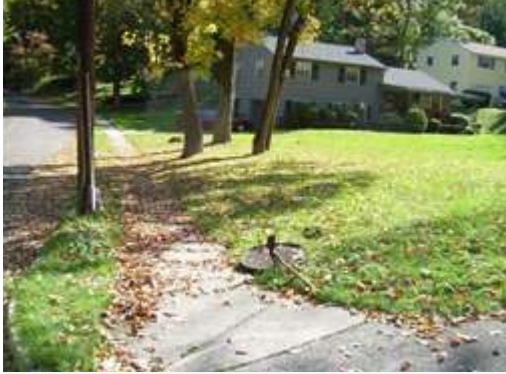
Location View

Sinkholes around MH

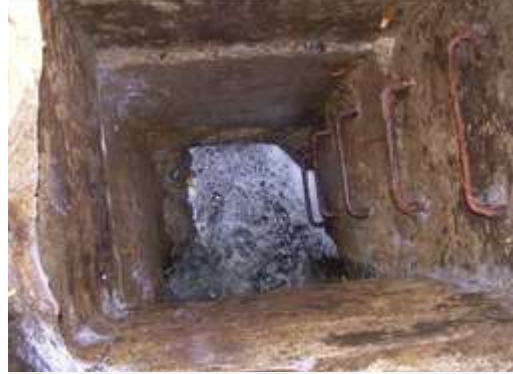
Top View

Adjustment infiltration. Corroded steps.

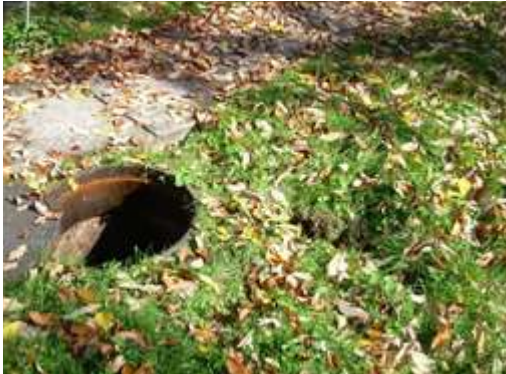
Comments **The ground around the manhole is collapsing. The rating is poor mainly due to the ground condition allowing of a lot of infiltration in when it rains. The**

The ground around the manhole is collapsing.

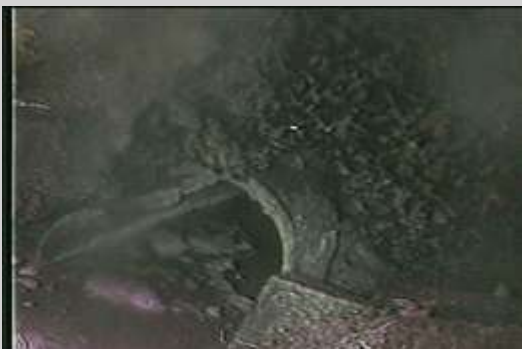
8 in. Circular Gravity Sewer Pipe In @ 3 O'Clock

Deposits: ☐ None ☒ **Mud** ☐ Sludge ☒ **Debris** ☒ **Grease**

Silt Depth: **2** (in.) Deposits Extent: **Light**

Infiltration: **Evidence** Pipe Seal Cond: **Unknown**

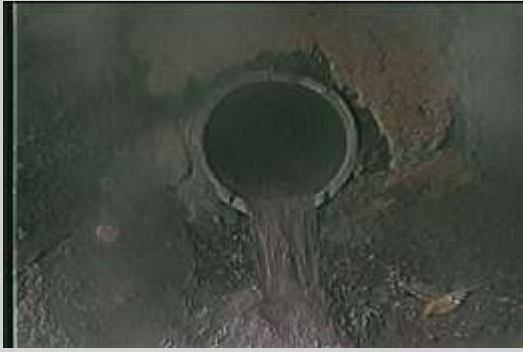
10 in. Circular Gravity Sewer

Barrel deterioration and infiltration.

Infiltration: **Evidence** Pipe Seal Cond: **Cracked**

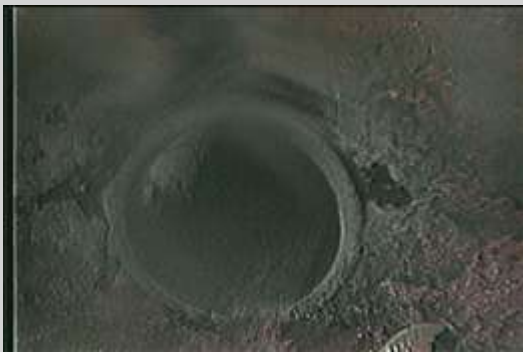
10 in. Circular Gravity Sewer

Infiltration: **Evidence** Pipe Seal Cond: **Cracked**
